Energy  
efficient  
Restoration

# Adaptive energy efficiency in historic buildings

By MAARTEN VIEVEEN (HANZE UNIVERSITY  
OF APPLIED SCIENCES, GRONINGEN)

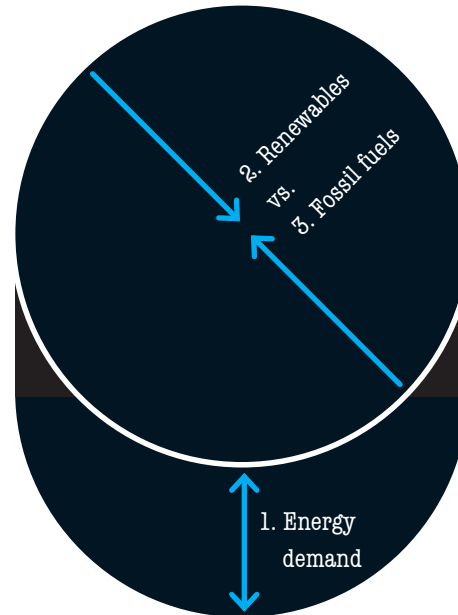
Figure 1: Trias Energetica (inspired by Lysen, 1996)

To summarise, the Trias Energetica is about: a) the energy demand, strategy 1, and; b) the energy source, strategy 2 and 3 (see figure 1).

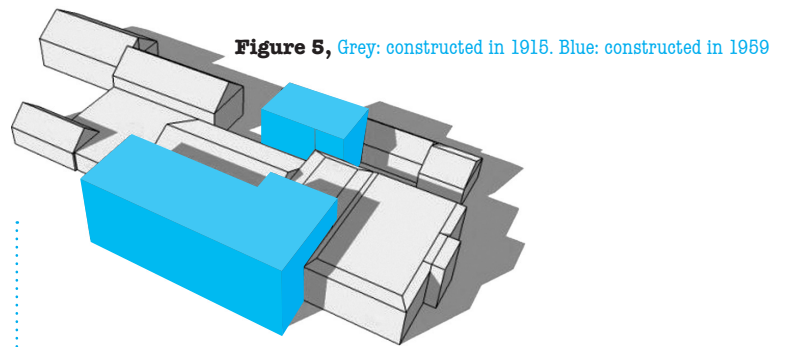
Figure 5, Grey: constructed in 1915. Blue: constructed in 1959

Since the number of members of the corporation increased fast to 400 members in 1958, more space was required and the factory was extended with a lab and an expedition room in 1959 (Figure 5). After merging with other dairy factories, the production process was limited to the production of exclusive cheese.

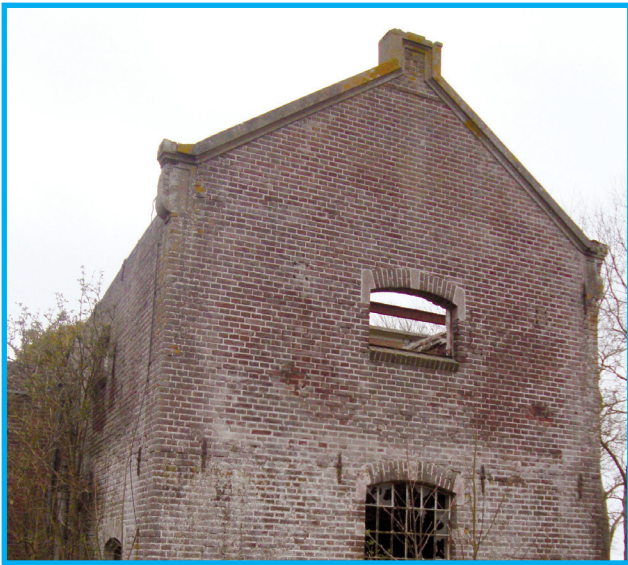
**Figure 6,** gable in the brick wall of a 1915 building

Buildings constructed in 1915 were based on a steel construction with (red) brick walls. The brick walls were provided with steel windows and ornaments on the gable. The roof is constructed with wooden beams covered with (dark brown, black and beige) roof tiles. When looking at the physical elements the gable (Figure 6), steel wall anchors and steels windows are characteristic for the construction period. Characteristic details are the façade of the factory with brick detailing and the factory name. Extensions constructed in 1959 were built out of (grey) concrete prefabricated panels (Figure 8) in a steel construction. The roof was covered with bitumen. Columns were constructed out of reinforced concrete. The walls were provided with (red and white painted) wooden windows. On the inside spaces were covered with (white) plaster and (yellow and black) ceramic tiles. Most of the interior elements are gone, with exception of the ceramic tiles (on the walls) and the basements of the removed milk tanks (Figure 7).

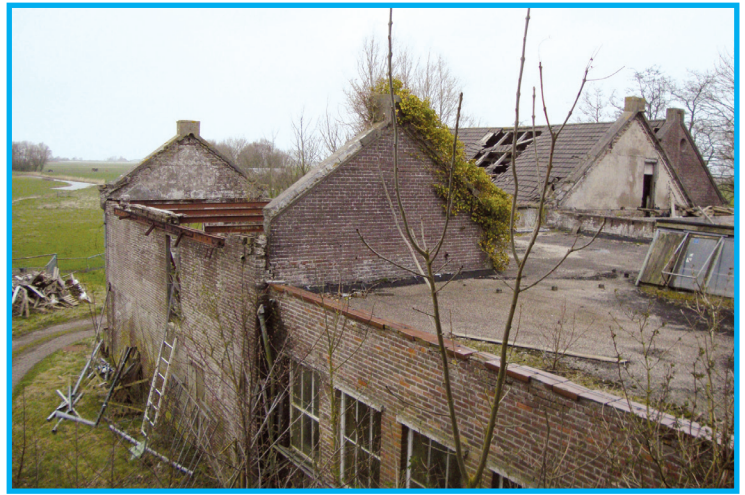
**Figure 9,** collapsed floors of the buildings from 1915

Since the buildings were not maintained in past decade, much damage was found. All of the buildings are in a bad technical condition, or even dangerous to enter. Most of the roofs of the old production buildings from 1915 had collapsed (**Figure 9**) and therefore the walls could be unstable. Also, some of the concrete panels from the buildings from 1959 fell down. Entering and walking around these parts of the buildings can be dangerous.

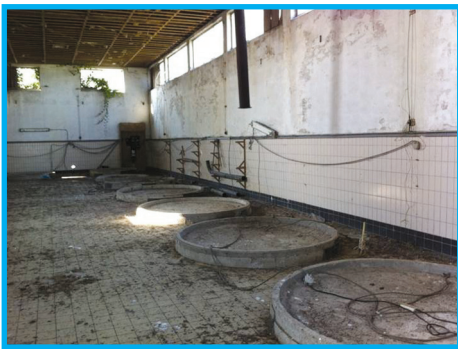
**Figure 7,** basement of the milk tanks

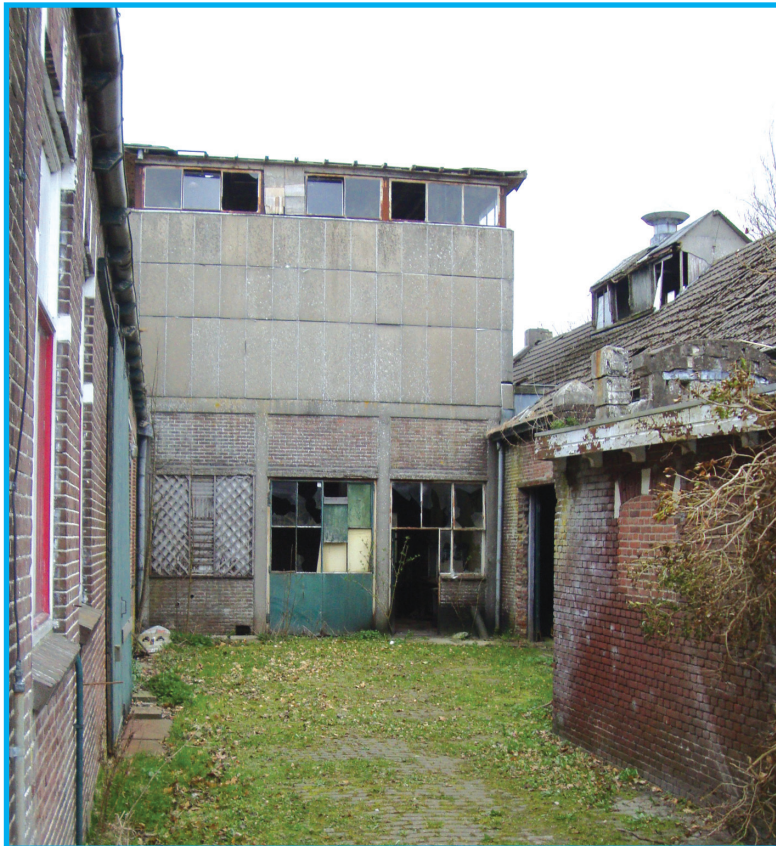
**Figure 8,** damaged concrete panels of the buildings from 1959

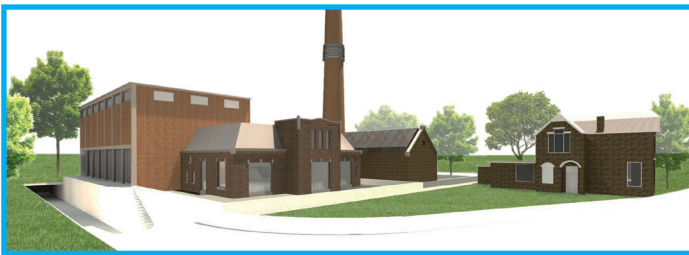
**Figure 11,** renovated dairy factory

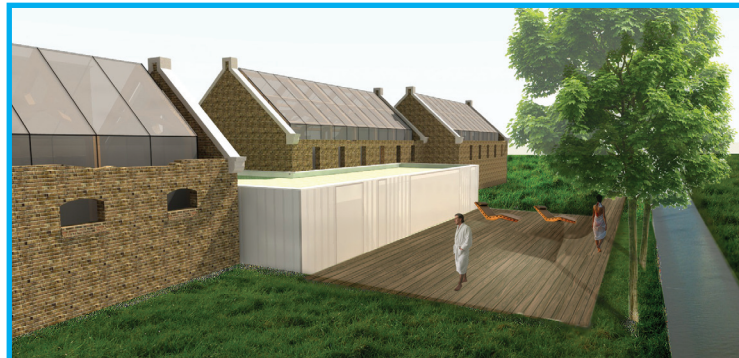
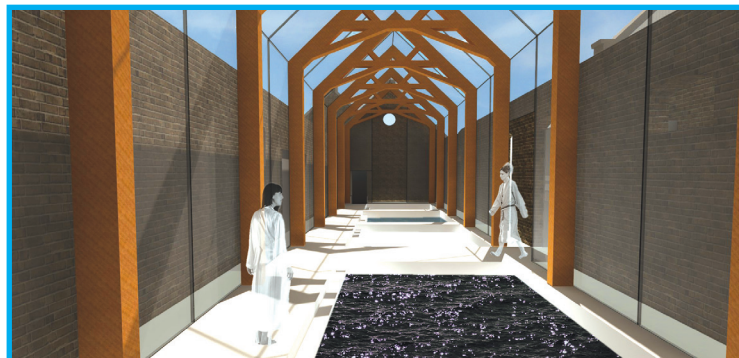
**Figure 12,** the glazed wellness baths

**Figure 13,** wellness baths

It was suggested to use the buildings constructed in 1915 for the wellness baths. The brick wall will be stabilised with a new inner glazed steel (box-in-a-box) construction (**Figure 12, 13**). The buildings constructed in 1959 will be used as dressing rooms, a sauna square (where the saunas are placed on top of the basements of the milk tanks, (**Figure 14**), massage rooms and café. The connecting space will be replaced by demolished and rebuilt since it is in a bad technical condition.

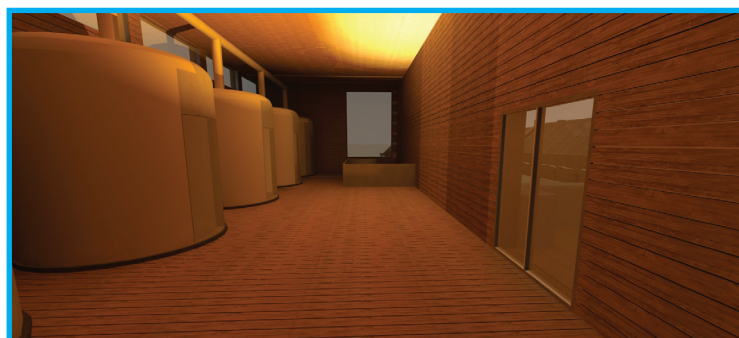
**Figure 14,** the sauna square

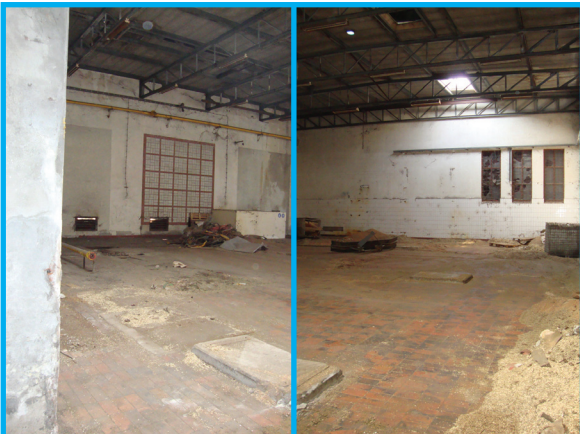
**Figure 17,** adjacent former steam boiler room

In 1929 the factory was extended and a steam engine installed. The steam engine room is tiled with glazed yellow and black tiles (Figure 16). The casing and front panels of the operating system are still intact although the copper wiring was stolen. The adjacent former steam boiler room at the corner of the complex was renewed in 1969 (Figure 17), the involved stakeholders valued this part of the buildings with lower/no heritage qualities.

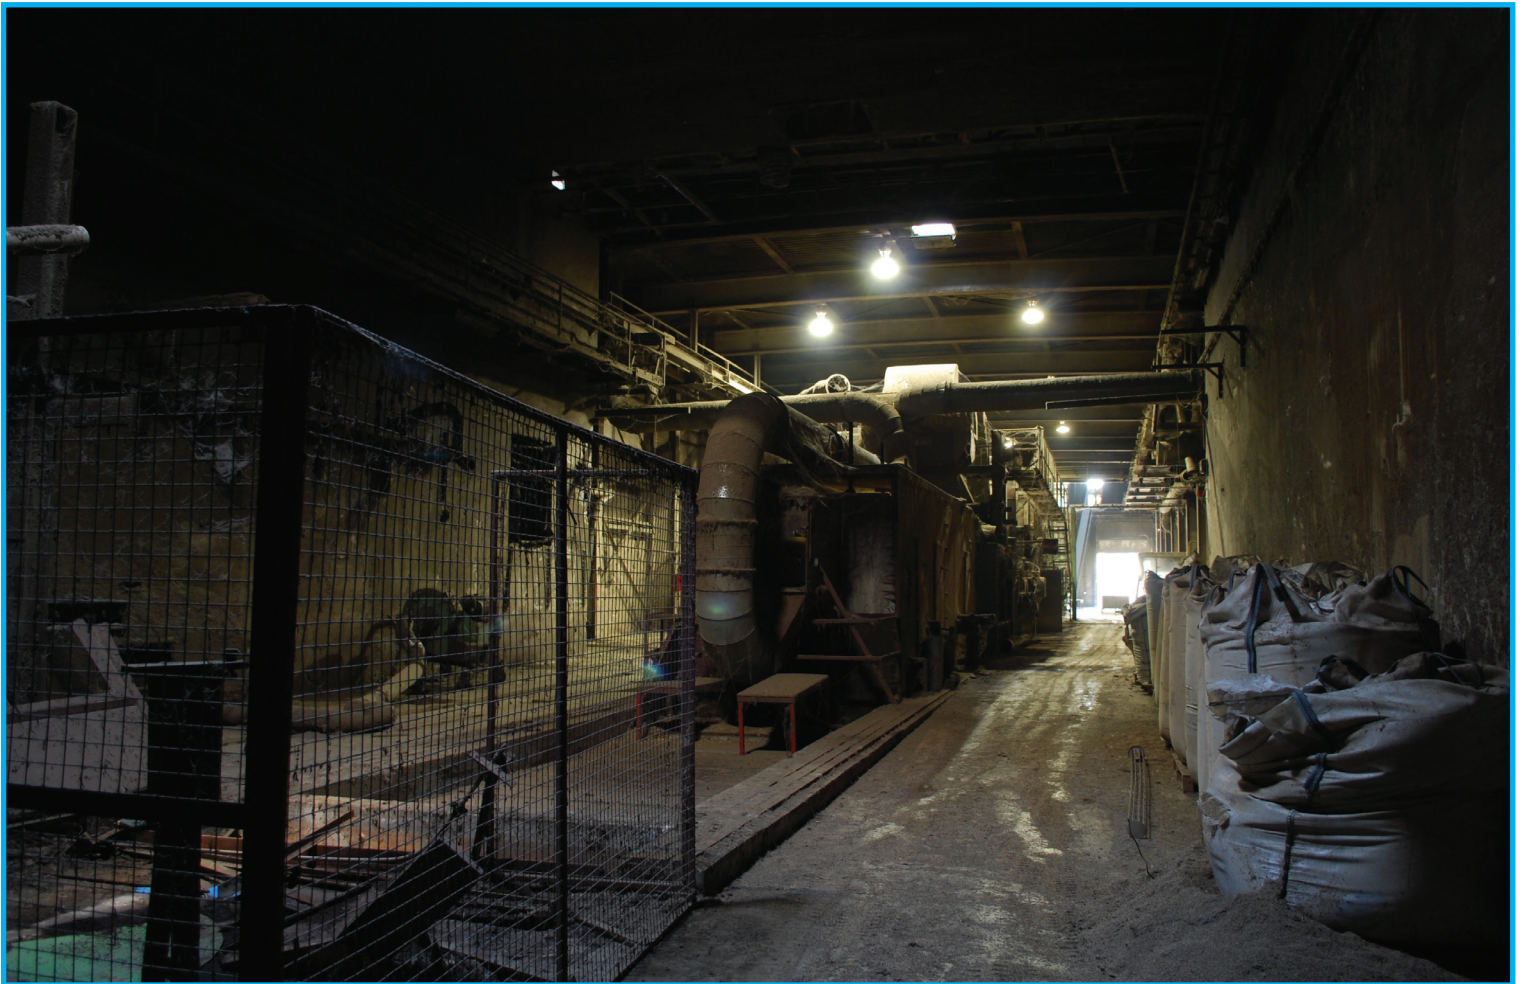
^ **Figure 18**, old strawboard production line

Nowadays the building is owned by HempFlax, which uses the historic buildings as a depot for surplus material. Today the steam engine room is largely authentic (original interior) and the depot rooms have been cleaned. Besides one strawboard production line (Figure 18) and the steam engine, only the large open spaces remind of the production process.

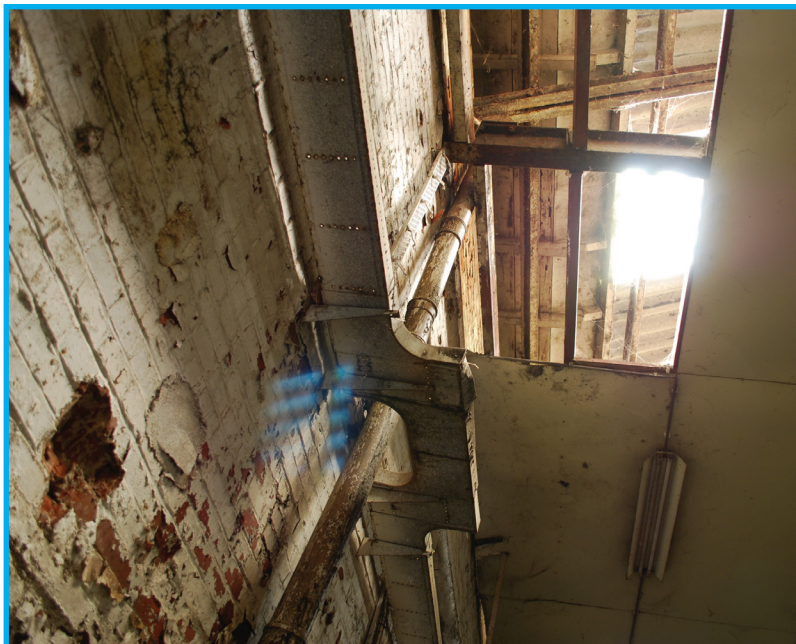
< **Figure 19**, leakage also caused other (serious) damage to the building

Some serious damage has emerged to a) the (asbestos) ceilings and roofs (leakage by moisture and vandalism); b) cracks in the walls related to soil failure that effected the foundation; c) the factory chimney was repaired with steel bands which no longer work effectively; d) window frames and the glass windows were effected by moisture and vandalism and; e) old electricity wiring (**figure 19**).

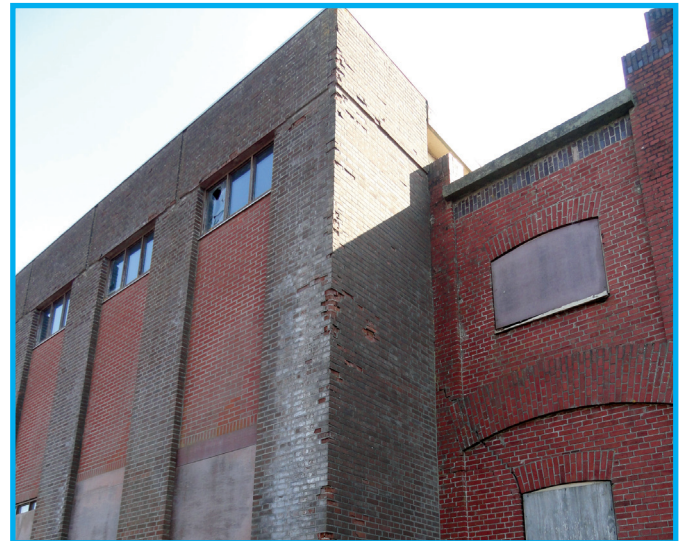
> **Figure 20**, damage to the brick walls

Also other elements suffered some damage, for example rusted steel beams, erosion of bricks (**Figure 20**), degraded sewer system, broken (glazed) tiles on the floor and walls, and damaged plaster on the inside and outside of the building.

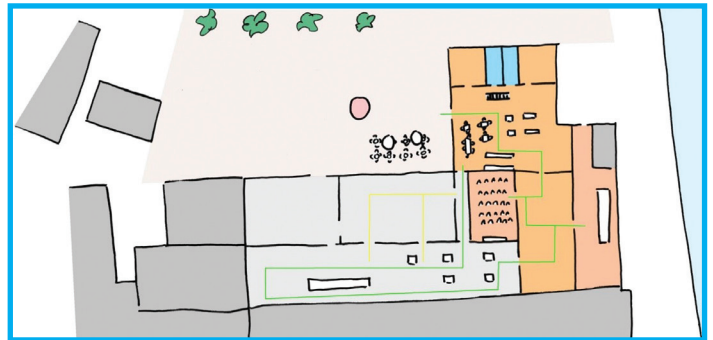
**Figure 21,** route of the museum

The developed plan suggested to use the route of the production line and heritage qualities as a basis for the layout of the former factory. The museum annex showroom/meeting room (**Figure 21**) can be entered from a central square into the former steam boiler room (**Figure 22**). Here visitors can buy tickets, merchandise and visit the restaurant.

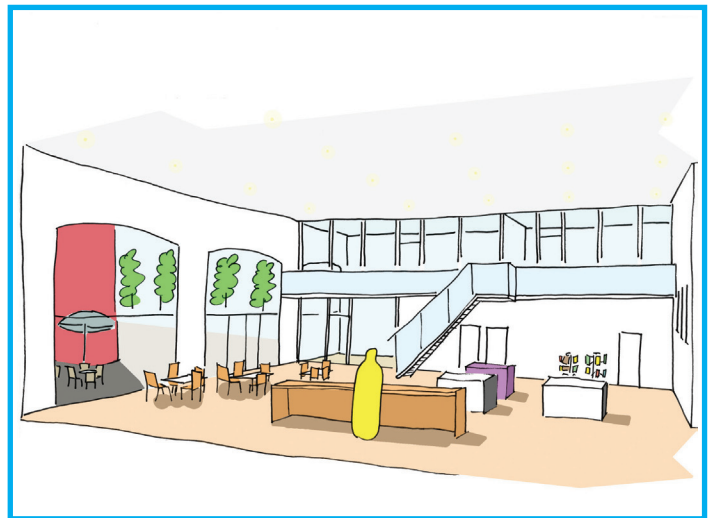
**Figure 22,** reception, café and showroom/meeting room in the former steam boiler room

The original steam engine room will be restored, taking the above measures into account. The spaces which housed the straw board production line and the steam boiler will be insulated on the inner side of the brick walls. Since the former steam boiler room was not valued with high heritage qualities, architectural interventions were suggested by placing large glazed windows in the facades and roofs.

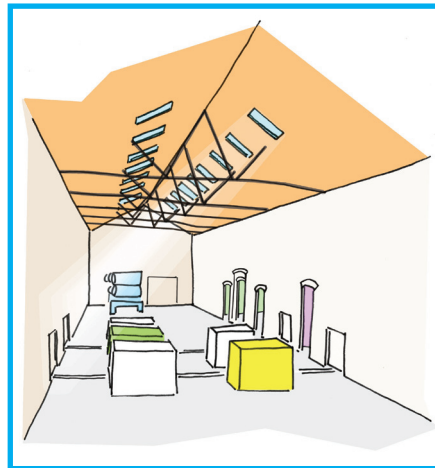
**Figure 23,** exhibition room in the former strawboard production line rooms

When moving further on people enter the former strawboard production line rooms. Here the history of the strawboard industry can be exhibited, but also art of local artists (**Figure 23**). Before entering the former steam boiler room again, visitors may watch a movie in the small theatre.
